# *Imagery Analysis Report*

Selected Locomotive and Railroad Car Plants  
Communist China

July 1968

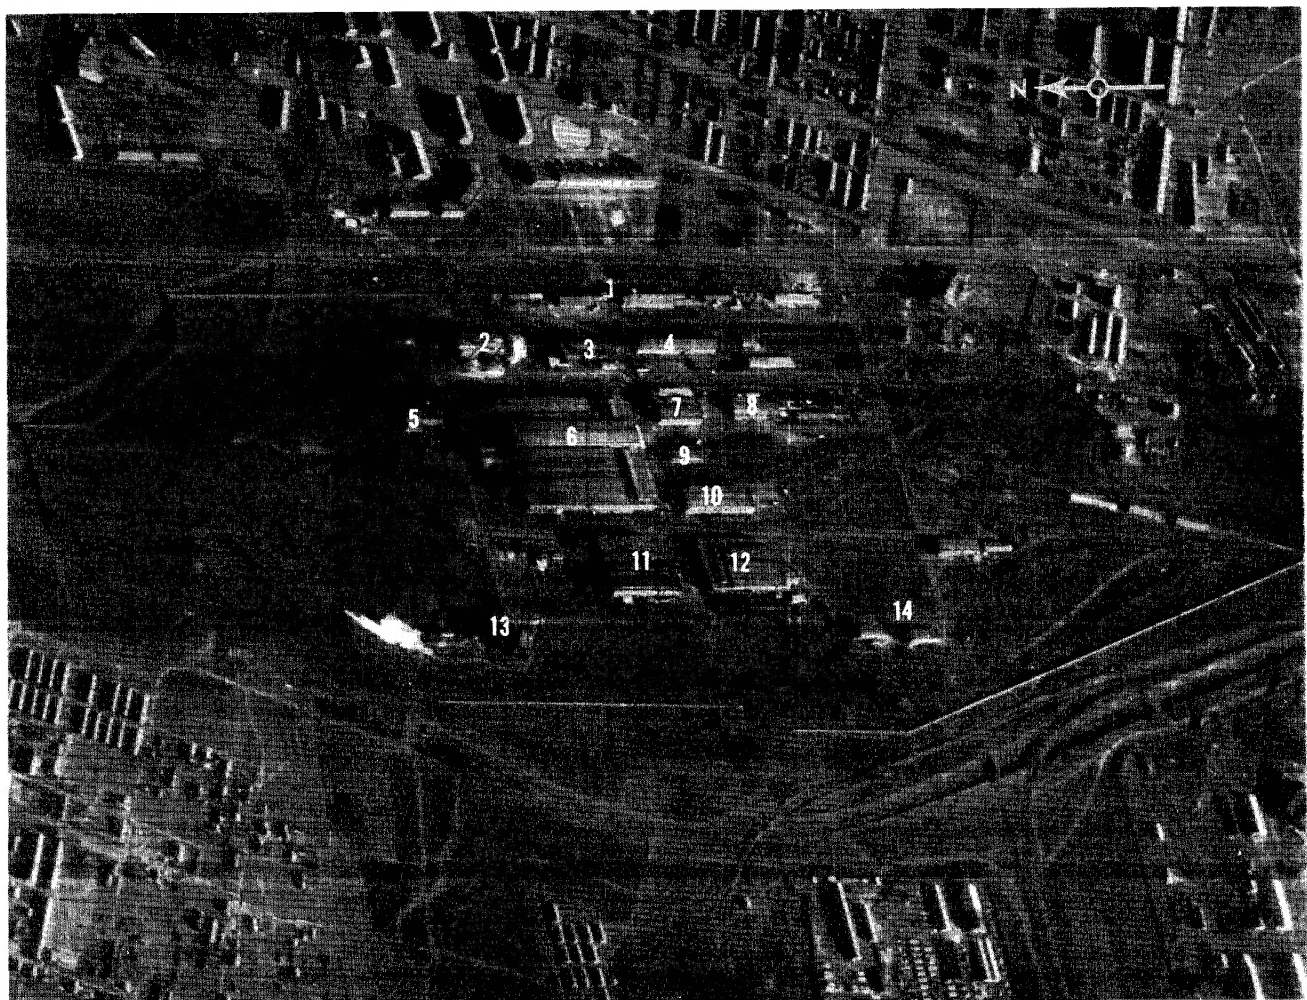
FIGURE 2. CHANG-CHUN RAILROAD LOCOMOTIVE MANUFACTURING AND REPAIR PLANT

The Chang-chun Railroad Locomotive Manufacturing and Repair Plant is located at 43-55-35N 125-18-36E (Figure 1, Item 1) in the northern suburbs of the city of Chang-chun. The plant is served by a good road network and by several rail spurs off the Chang-chun to Ssu-ping Rail Line.

The entire plant occupies an area of approximately 115 acres and has 491,000 square feet of roof cover. When the plant was first observed on imagery of [REDACTED] it appeared that all of the major buildings were complete. An accurate analysis of the plant could not be accomplished due to poor-quality imagery. The plant was next observed [REDACTED] and all of the major buildings were complete and in operation with the exception of Items 2, 5, and 7 which were in the early stages of construction. The construction of these three buildings continued [REDACTED] when they were first observed complete. Railcars were observed within the plant [REDACTED]

<u>Item</u>	<u>Description</u>	<u>Item</u>	<u>Description</u>
1	Support Buildings (2)	8	Workshop
2	Steam Plant	9	Workshop
3	Probable Forge Shop	10	Repair Shop
4	Warehouse	11	Foundry Shop
5	Unidentified Workshop	12	Probable Forge Shop
6	Assembly Building	13	Administration Building
7	Workshop	14	Support Buildings (2)

Note: This plant is mainly a repair facility at the present time.

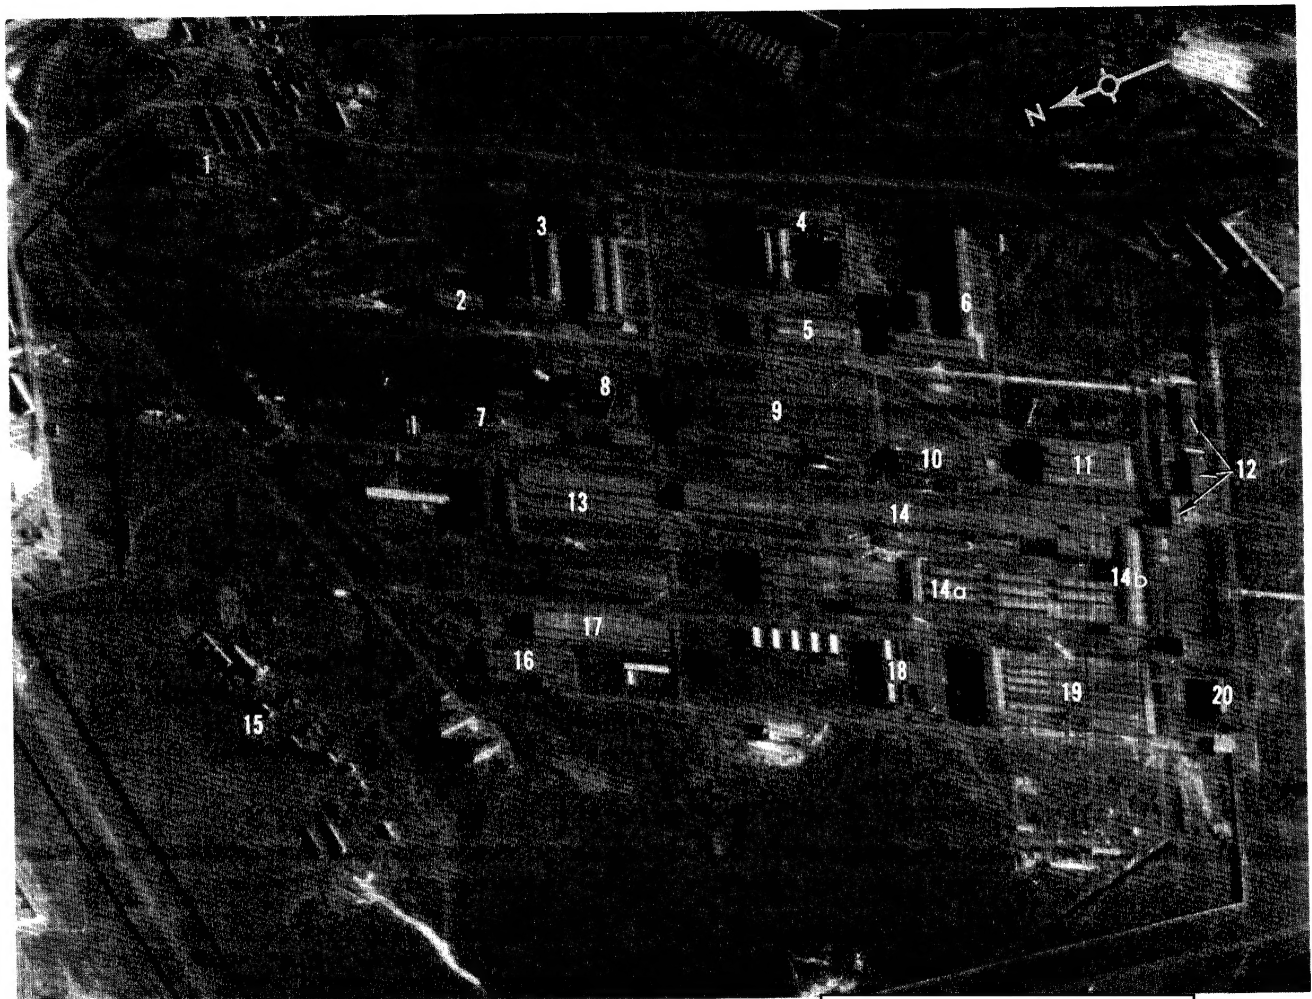
FIGURE 3. CHANG-CHUN RAILROAD CAR MANUFACTURING PLANT

The Chang-chun Railroad Car Manufacturing Plant [REDACTED] is located at 43-54-33N 125-17-40E (Figure 1, Item 2) in the northwest suburbs of Chang-chun. The plant is served by a good road network and a rail spur off the rail line extending from Chang-chun to Ssu-ping.

The entire plant occupies an area of approximately 320 acres and has 1,410,000 square feet of roof cover. The plant was first observed on imagery [REDACTED] however, due to imagery of poor quality, an analysis of the plant could not be accomplished. When next observed in [REDACTED] all of the major facilities were complete, with the exception of two forge buildings (Items 4 and 6). The plant was operating, with numerous rail cars located within the area. When the plant was next observed [REDACTED] the two forge buildings were complete. The plant was operating each time it was observed [REDACTED]

<u>Item</u>	<u>Description</u>	<u>Item</u>	<u>Description</u>
1	Unidentified Workshop	12	Administration Buildings (2) and a Vehicle Shed
2	Possible Sand Preparation Building	13	Assembly Building
3	Foundry	14	Machine Shop/Subassembly
4	Probable Forge Shop	14a	Assembly Section
5	Workshop	14b	Subassembly Section
6	Probable Forge Building	15	Inactive Steel Mill
7	Workshop	16	Workshop
8	Steam Plant	17	Workshop
9	Machine Shop	18	Woodworking Shop
10	Warehouse	19	Machine Shop/Subassembly Building
11	Workshop	20	Workshop

Note: This plant is presently producing passenger cars.

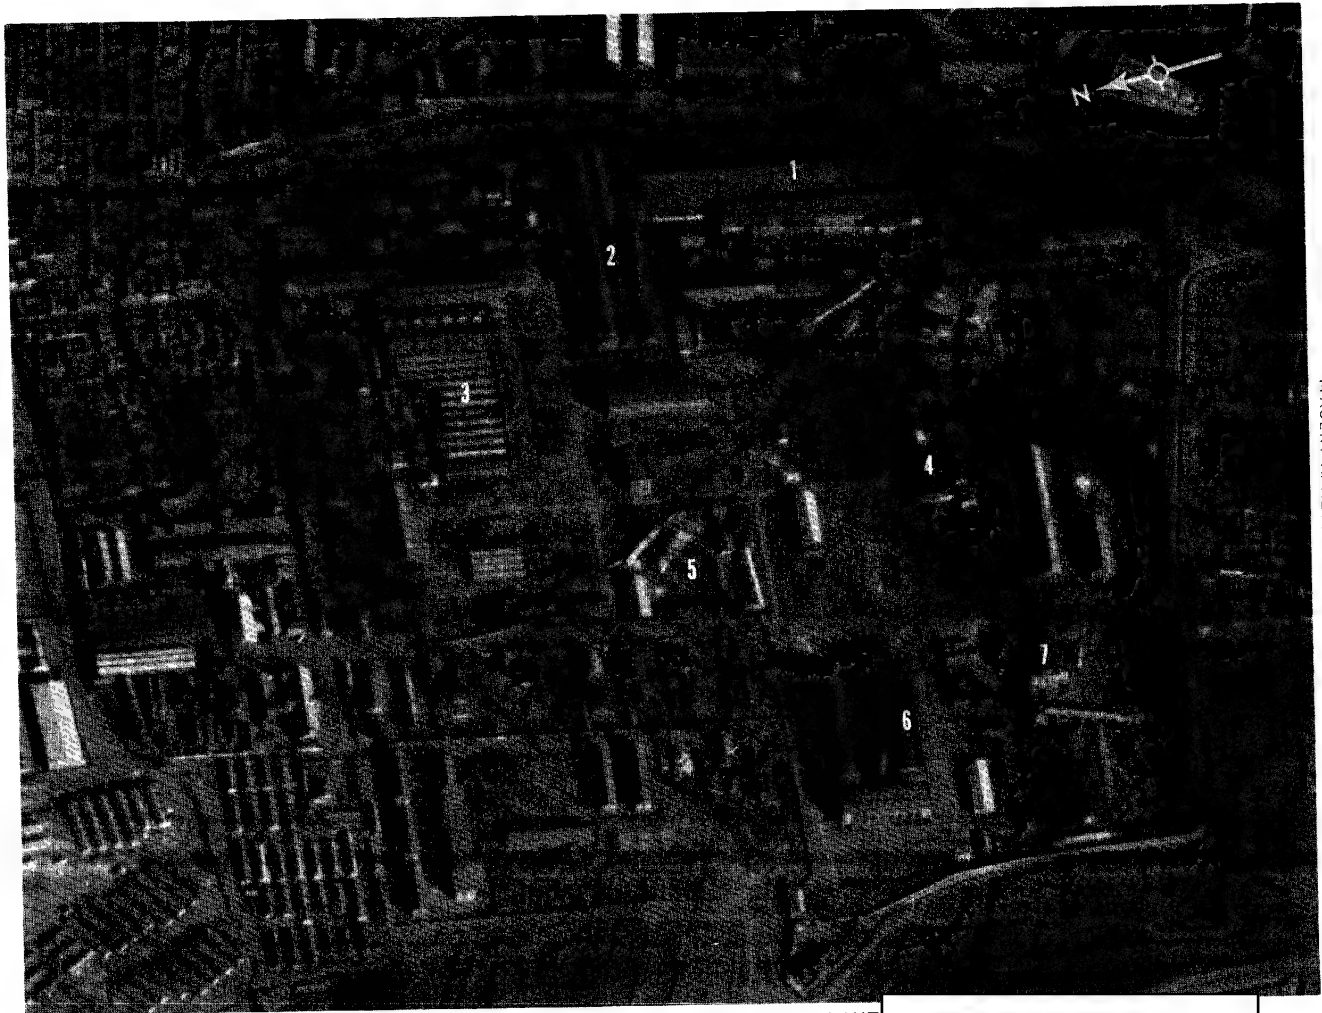
FIGURE 4. CHANG-HSING-TIEN LOCOMOTIVE AND ROLLING STOCK PLANT

The Chang-hsing-tien Locomotive and Rolling Stock Plant [REDACTED] is located at 39-49N 116-11E (Figure 1, Item 3) approximately 11 nautical miles southwest of the city of Peking. The plant is served by a good road network and a rail spur off the rail line extending from Peking to Liu-li-ho.

The entire plant occupies an area of approximately 70 acres and has 489,000 square feet of roof cover. The plant was first observed on imagery [REDACTED]. However, due to poor-quality imagery, an analysis of the facilities could not be accomplished. When the plant was next observed [REDACTED] all of the major facilities were complete. The plant appeared to be operating with numerous rail cars observed throughout the entire area.

From a comparison of available imagery [REDACTED] no additional construction activity was noted. The plant appeared to be operating when observed on all available imagery.

<u>Item</u>	<u>Description</u>	<u>Item</u>	<u>Description</u>
1	Assembly Building	5	Support Area
2	Machine Shop	6	Forge Building
3	Workshop	7	Steam Plant
4	Foundry

Note: This plant is mainly a repair facility at the present time.

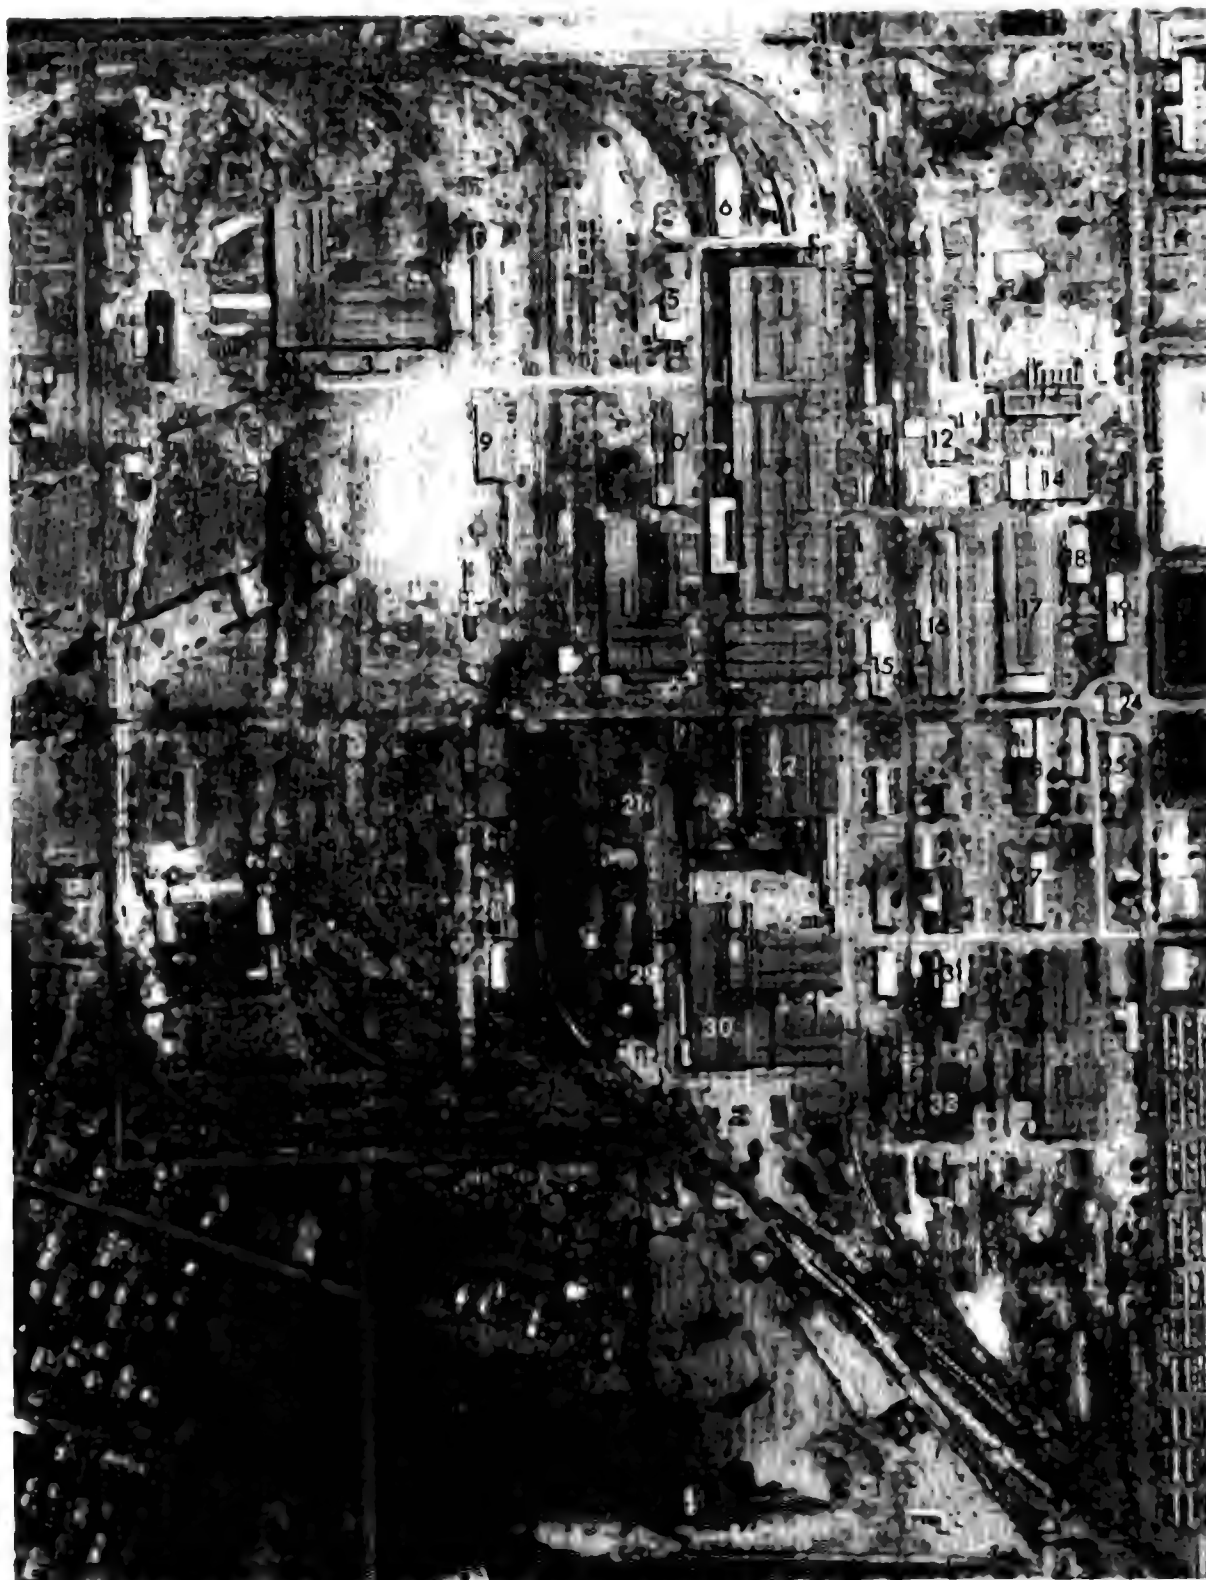
FIGURE 5. CHI-CHI-HA-FEN RAILROAD CAR MANUFACTURING AND REPAIR PLANT,

The Chi-chi-ha-erh Railroad Car Manufacturing and Repair Plant [redacted] is located at 47-20-55N 124-00-50E (Figure 1, Item 4) within the city of Chi-chi-ha-erh, China. The plant is served by an excellent road network and several rail spurs.

The entire plant occupies an area of approximately 330 acres and has 1,630,000 square feet of roof cover. When the plant was first observed on imagery [redacted] all of the major buildings were complete, and no construction activity was noted. Imagery [redacted] revealed a new workshop (Item 28) under construction. When the plant was next observed [redacted] the construction of the workshop (Item 28) was suspended, and a workshop (Item 1) was undergoing repairs. There was no construction activity noted until [redacted] a new saw mill (Item 13) and an addition to the forge and foundry were observed under construction. When observed [redacted] the workshop (Item 28) was then complete.

[redacted] When the plant was last observed [redacted] the workshop (Item 1) was still under construction.

<u>Item</u>	<u>Description</u>	<u>Item</u>	<u>Description</u>
1	Workshop	18	Warehouse
2	Foundry	19	Administration Building
3	Administration Building	20	Workshop
4	Warehouse	21	Steam Plant
5	Workshop	22	Forge Building
6	Warehouse	23	Possible Forge Building
7	Assembly and Final Check-out Building	24	Administration Building
8	Warehouse	25	Warehouse
9	Workshop	26	Workshop
10	Workshop	27	Probable Foundry
11	Forge Building	28	Workshop
12	Possible Saw Mill and Wood Drying Kilns	29	Producer Gas Plant
13	Saw Mill	30	Forge and Foundry Building
14	Warehouse/Workshop	31	Forge Building
15	Workshop	32	Railroad Car Repair Shop
16	Workshop	33	Foundry Building
17	Workshop	34	Warehouse

Note: This plant is presently producing freight cars.

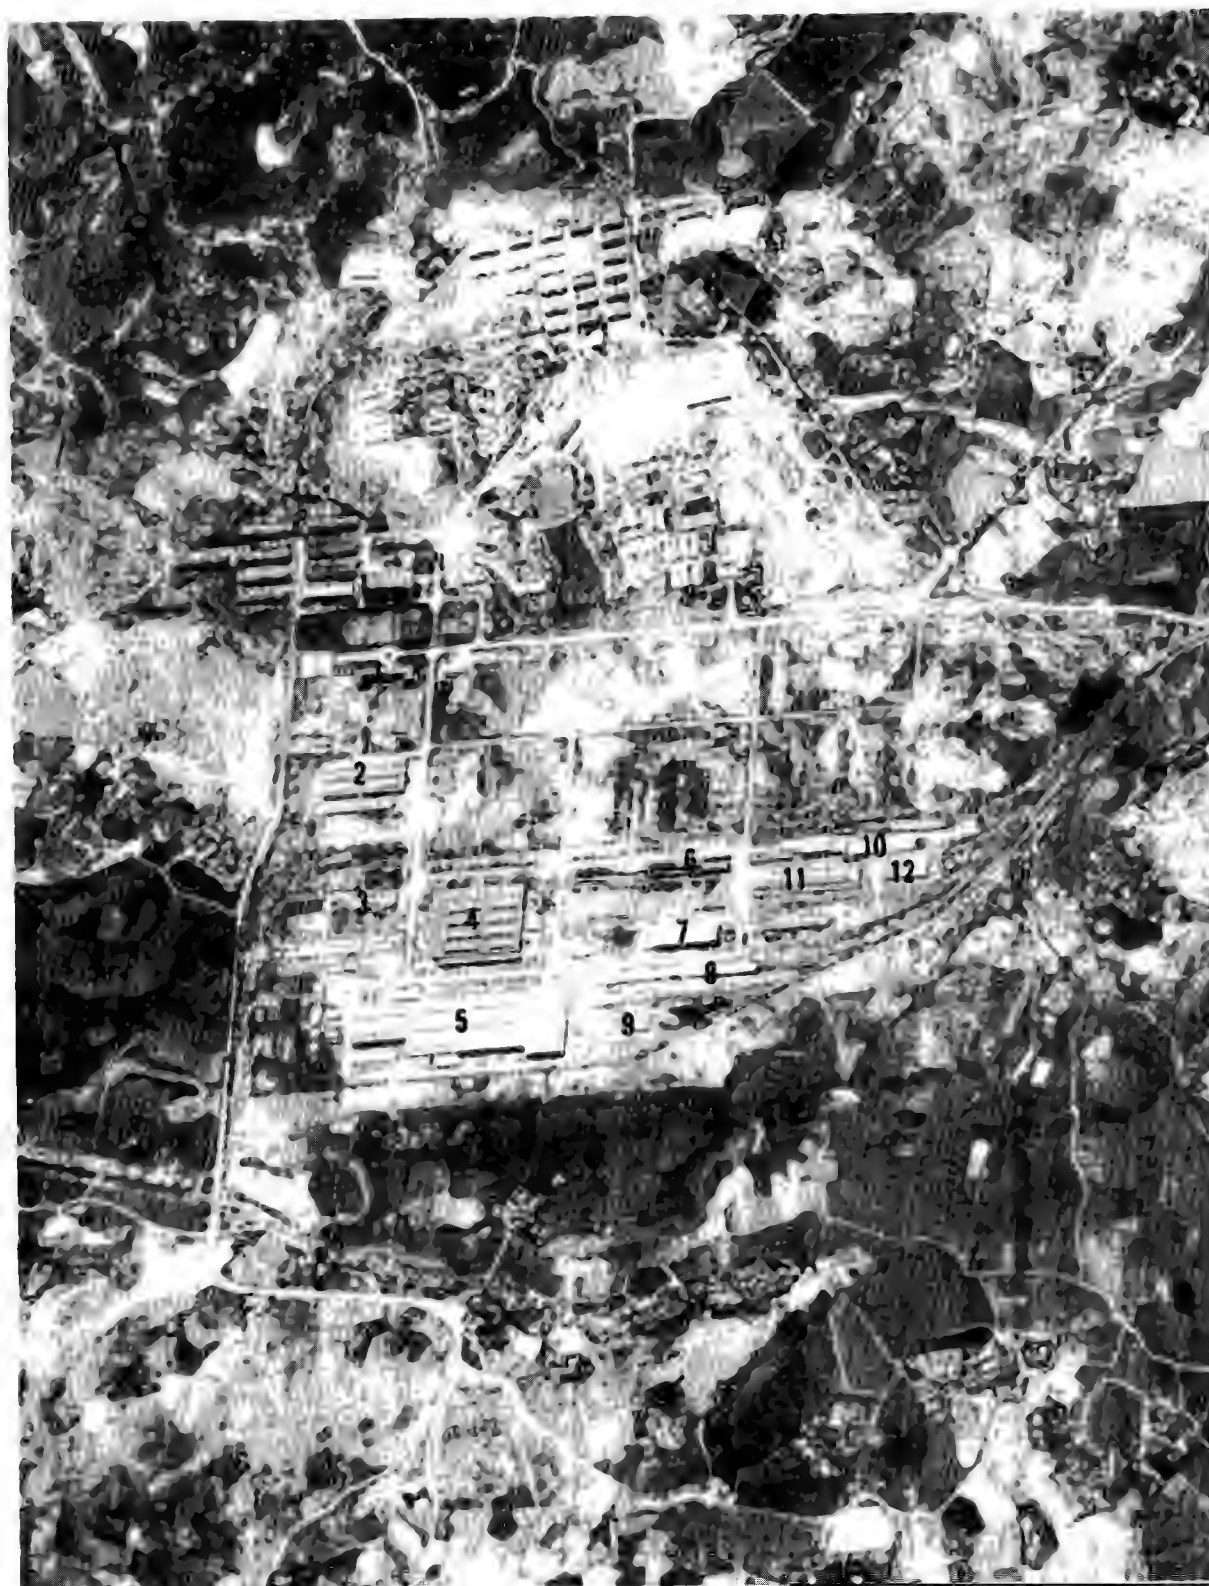
FIGURE 6. CHU-CHOU RAILROAD CAR MANUFACTURING PLANT

The Chu-chou Railroad Car Manufacturing Plant is located at 27-53-00N 113-12-00E (Figure 1, Item 5) approximately 4 nautical miles northeast of the city of Chu-chou. The plant is served by a good road network and a 3-nautical-mile rail spur from the Chu-chou to Hsiang-tan Railroad.

The entire plant occupies an area of approximately 140 acres and has 515,000 square feet of roof cover. When the plant was first observed on imagery [REDACTED] 90 percent of the area was obscured by heavy clouds. Only one warehouse (Item 2) could be observed and was complete. When next observed [REDACTED] the area that was previously obscured by clouds was clear, revealing the existence of five additional buildings (Items 1, 3, 4, 6, and 11). It is impossible to determine whether or not these five buildings had existed on the earlier imagery [REDACTED] Imagery [REDACTED] revealed the plant in operation. Numerous railroad cars were observed throughout the plant area. Construction then halted [REDACTED] when a new addition to the final check-out building (Item 6) and the construction of a new warehouse (Item 12) were observed.

[REDACTED] At the present time only approximately 50 percent of the plant area is being used, leaving the other half of the area for later expansion. The road network for this portion has already been constructed. The plant was operating on all imagery [REDACTED]

<u>Item</u>	<u>Description</u>	<u>Item</u>	<u>Description</u>
1	Administration Building	7	Workshop
2	Warehouse	8	Final Check-out Building
3	Forge Building	9	Possible Steam Plant
4	Final Assembly Building	10	Warehouse
5	Final Assembly Building	11	Warehouse
6	Final Check-out Building	12	Warehouse

Note: This plant is presently producing freight cars.

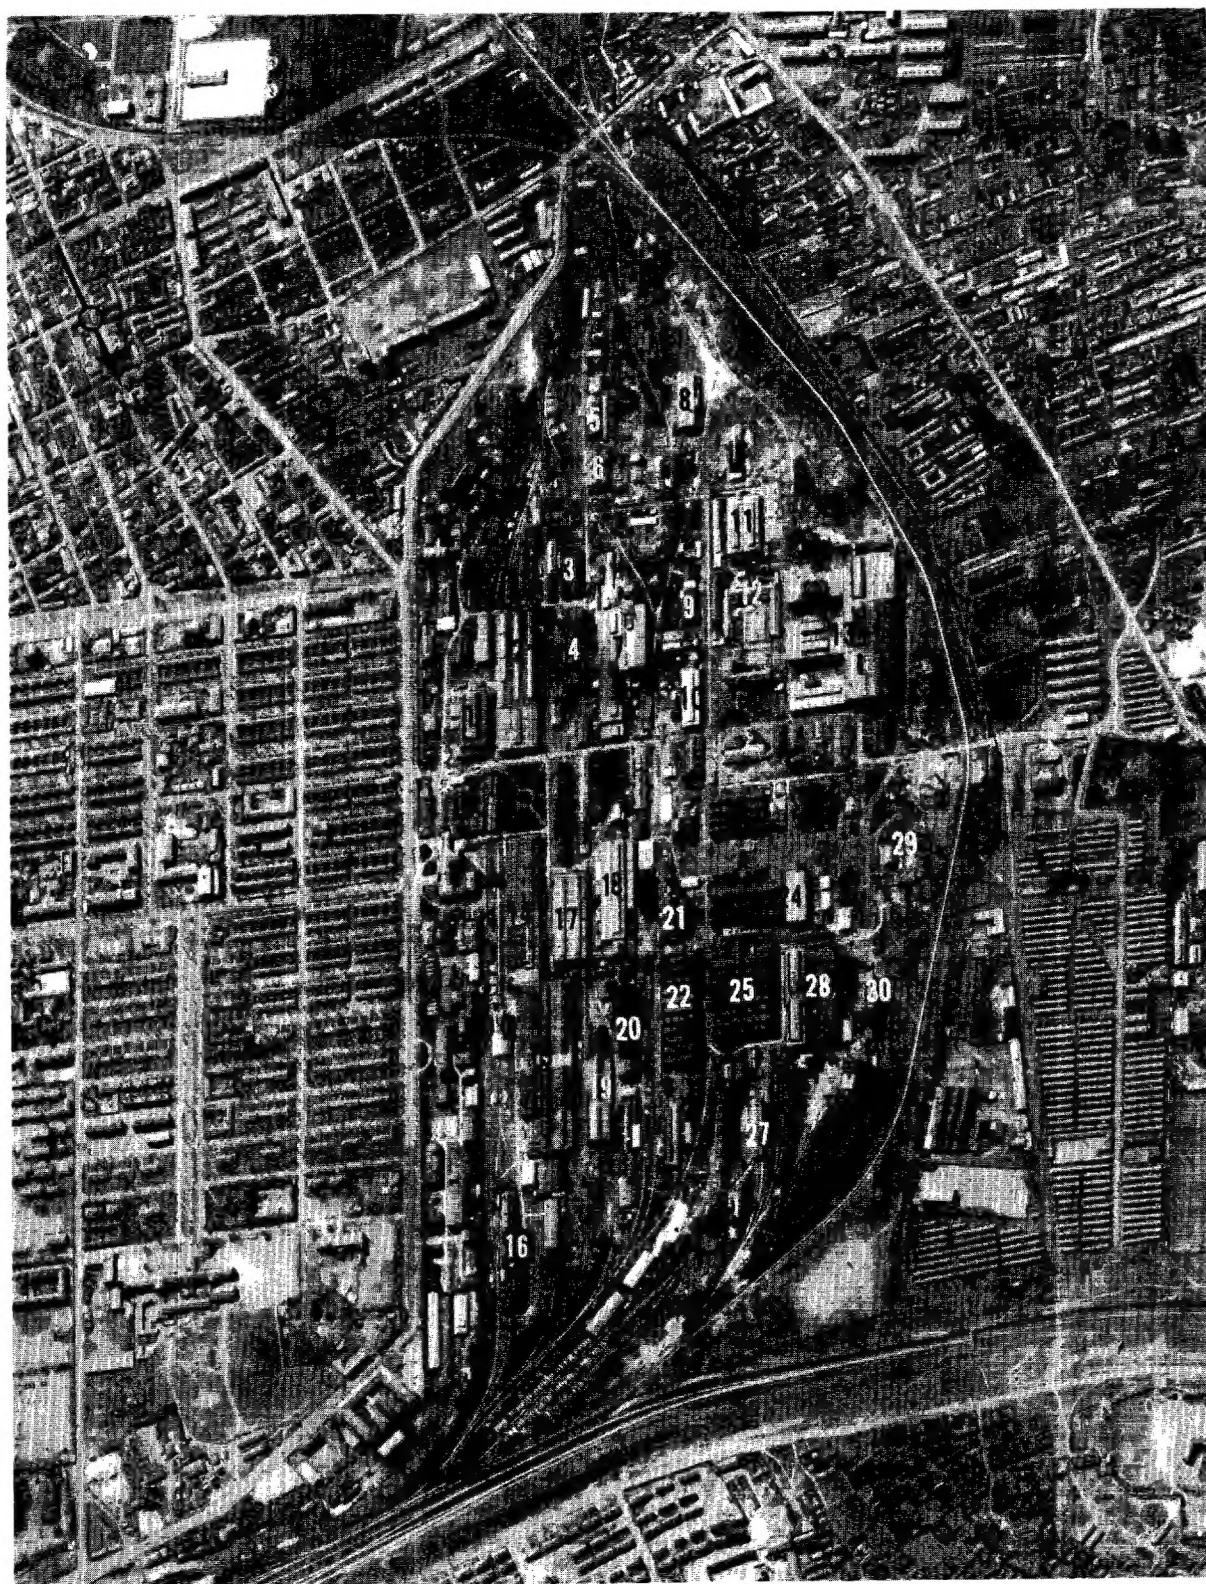
FIGURE 8. LU-TA RAILROAD LOCOMOTIVE AND CAR MANUFACTURING AND REPAIR PLANT,

The Lu-ta Railroad Locomotive and Car Manufacturing and Repair Plant is located at 38-55-10N 121-34-25E (Figure 1, Item 7) within the city of Lu-ta. The plant is served by a good road network and several railroad spurs.

The entire plant occupies an area of approximately 250 acres and has 1,255,000 square feet of roof cover. The plant was complete and in operation when first observed. Numerous railroad cars of various types were scattered throughout the plant. no construction activity was noted. However, analysis of imagery revealed that approximately 30 percent of the possible final check-out building (Item 26) was dismantled and that a new final check-out building (Item 27) was constructed. The plant was operating when last observed.

<u>Item</u>	<u>Description</u>	<u>Item</u>	<u>Description</u>
1	Workshop	16	Final Check-out Building
2	Assembly Building	17	Possible Machine Shop
3	Warehouse	18	Foundry
4	Forge Building	19	Possible Machine Shop
5	Warehouse	20	Warehouse
6	Workshop	21	Steam Plant
7	Possible Foundry	22	Possible Assembly Building
8	Final Check-out Building	23	Assembly Building
9	Warehouse	24	Assembly Building
10	Warehouse	25	Assembly Building
11	Possible Machine Shop	26	Possible Final Check-out Building
12	Workshop	27	Final Check-out Building
13	Foundry	28	Forge Building
14	Subassembly Building	29	Substation
15	Assembly Building	30	Steam Plant

Note: This plant is presently producing freight cars and locomotives.
